An Evaluation of Road Pavement Failure Along Awotan - Akufo Road, Oyo State, Southwestern Nigeria.

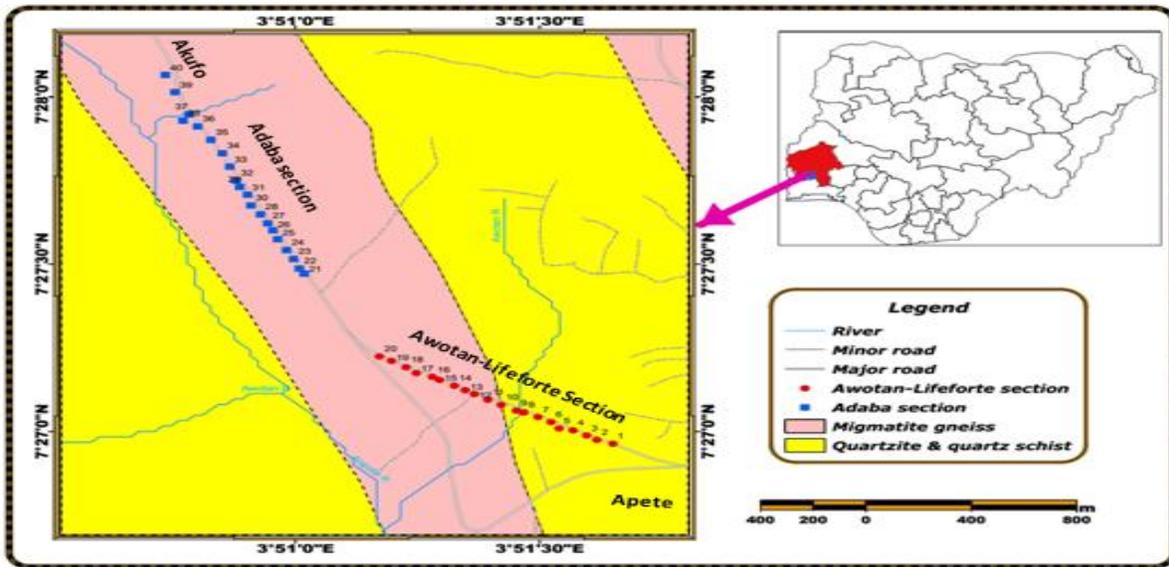
Fig. 2. Geological Map of the Area Around the Investigated Road [16]

Awotan -Akufo road is located within the Ido Local government area of Oyo State, southwestern Nigeria. The failed segments investigated lie within latitudes $7^{\circ}26' 57.88''\text{N}$ and $7^{\circ}26' 13.52''\text{N}$, and longitudes $3^{\circ}51' 38.99''\text{E}$ and $3^{\circ}51' 10.32''\text{E}$ which comprises of areas like Awotan, Life-forte, Tipper garage, Adaba and Alapata all along Akufo road. The area has a unique environmental setting characterized by a wide range of land-use activities such as small scale arable farming, animal husbandry, poultry, fish pond activity, residential and commercial settlements. The topography is gently undulating with elevation ranging from 199.8m to 244.6m above sea level and characterized with isolated inslbergs, drained dendritically by River Alapata and its tributaries (Fig.1). The soil type is characterized by fine to medium to coarse grain, brown to reddish brown sandy clay fraction (Table 1). The study area lies within the crystalline Basement Complex rocks of southwestern Nigeria. The rock types underlying the area belong to the Migmatite-gneiss-quartzite complex [13; 14; 15] consisting majorly of Quartzite, Quartz Schist ridges and minor Migmatite Gneiss (Fig. 2). Residual soils such as laterites, resulting from the weathering and decomposition of the Pre-Cambrian Basement rocks cut across the various rock types mentioned above
