Original Research Article

Geotechnical

An Evaluation of Road Pavement Failure Along Awotan - Akufo Road, Oyo State, Southwestern Nigeria.

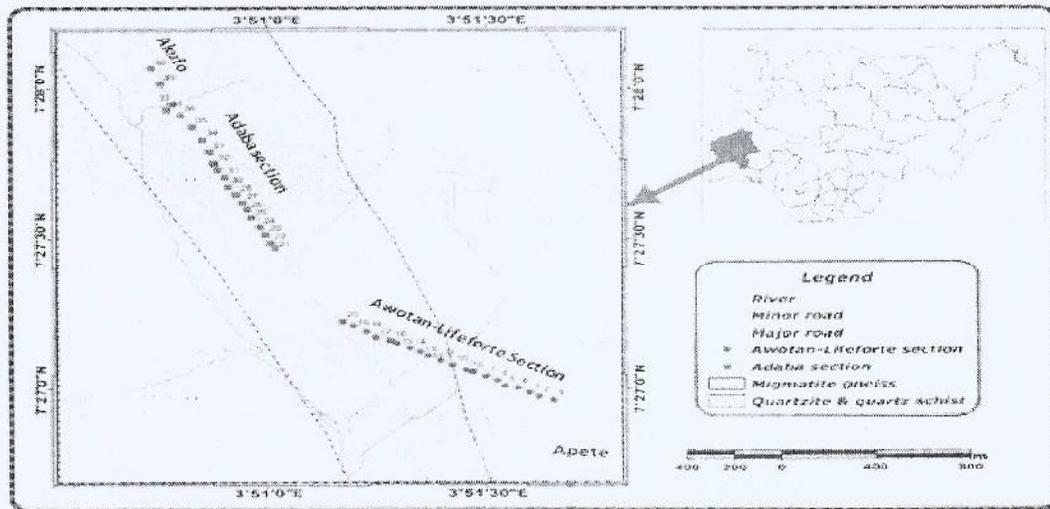
Fig. 2. Geological Map of the Area Around the Investigated Road [16]

Awotan -Akufo road is located within the Ido Local government area of Oyo State, southwestern Nigeria. The failed segments investigated lie within latitudes $7^{\circ}26' 57.88''N$ and $7^{\circ}26' 13.52''N$, and longitudes $3^{\circ}51' 38.99''E$ and $3^{\circ}51' 10.32''E$ which comprises of areas like Awotan, Life-torte, Tipper garage, Adaba and Alapata all along Akufo road. The area has a unique environmental setting characterized by a wide range of land-use activities such as small scale arable farming, animal husbandry, poultry, fish pond activity, residential and commercial settlements. The topography is gently undulating with elevation ranging from 199.8m to 244.6m above sea level and characterized with isolated ^{inselbergs} ~~inslbergs~~, drained dendritically by River Alapata and its tributaries (Fig.1). The soil type is characterized by fine to medium to coarse grain, brown to reddish brown sandy clay fraction (Table 1). The study area lies within the crystalline Basement Complex rocks of southwestern Nigeria. The rock types underlying the area belong to the Migmatite-gneiss-quartzite complex [13; 14; 15] consisting majorly of Quartzite, Quartz Schist ridges and minor Migmatite Gneiss (Fig. 2). Residual soils such as laterites, resulting from the weathering and decomposition of the Pre-Cambrian Basement rocks cut across the various rock types mentioned above, ^{in selba}
