**THE DESIGN AND CONSTRUCTION OF AN INTELLIGENT DEVICE
FOR COATING FLAWS AND CRACK DETECTION IN PIPELINES**

Abstract: *The major pollutant induced by pipeline failure in Oil and Gas industry in Nigeria has been mitigated over the years using non-destructive techniques like liquid penetrant, magnetic particles, radiographic, ultrasound and eddy current testing. The eddy current technique's advantages over the other testing devices remains to best suitable in the design and construction of the devices due to the nature of the pipeline materials. For this present work, a pre-test-post-test experimental design was used to test device on a defect free pipe and a pipe with machined defects of known dimensions and different orientation (longitudinal and axial) after construction. The defect detection was done using electromagnetic technique of eddy current by exciting a coil with power supply and placed close to pipe surface as a micro-controller was used to track irregularities on the material surface by computer systems. The device set up for the test was a coil with a power supply of a DC battery connected with micro-controller of a quantization level of 4.88mV. For visual display, re

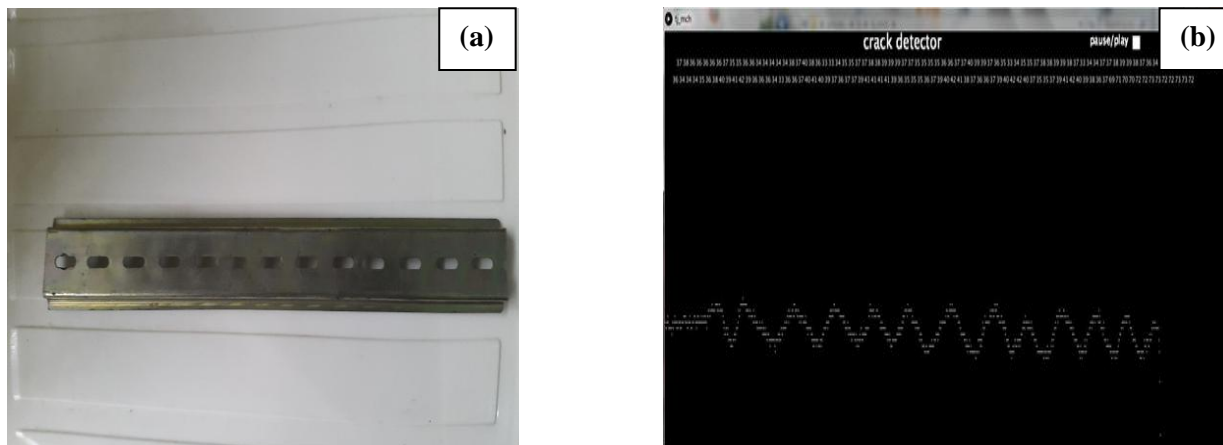
245 The device was initially calibrated with a steel plate 260mm by 35mm with 12 holes machined on it. The
246 holes have dimensions of 12mm by 4mm and are evenly spaced along the surface of the plate with
247 equidistance of 8mm. The display on the screen showed clearly the effect of the holes on the coil that is

248 been moved along the surface of the plate. The metal plate and also result from the calibration of the
249 device using the steel plate are depicted in Fig. 1 below.

250
251 **Figure 1(a):** The metal plate used to calibrate the device **(b)** Result showing the twelve holes on the tested device

269 The result from the calibration was validated by doing a visual inspection of the metal plate, this was followed by
270 testing the device on a pipe. Two Galvanized test pipes were purchased and cut into smaller lengths of 300mm with

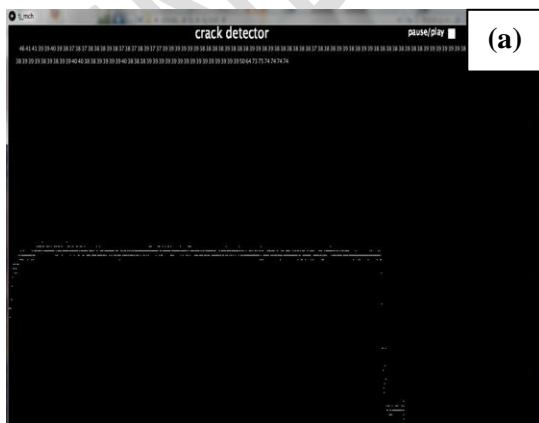
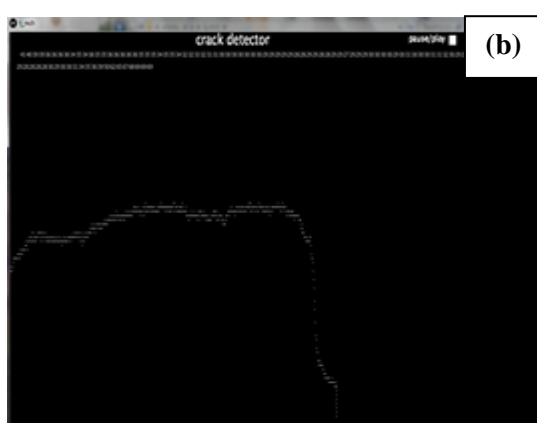
318 This test shows the response of the coil on a defect free pipe. At the start of the test lift off caused a little
 319 change in the pulse signal but as the test progressed it was eliminated by maintaining a constant distance
 320 between the coil and the pipe. The relatively straight pulse signal shown on the screen of the computer
 321 system was expected as the impedance on the coil was relatively constant and was not and altered in
 322 anyway due to absence of any form of defect on the test pipe. Shown below in Fig. 5 and Fig. 6 are the
 323 visual display of the test conducted using the Processing 3 software on a computer system. The numbers
 324 at the top of the screen is just to show the numerical values of the nverse of the change in impedance on
 325 the coil which is in line with the pulse signal displayed.

326
327 **Figure 5:** Result from the tested done galvanized pipe (a) without defects (b) with longitudinal defects in section 1

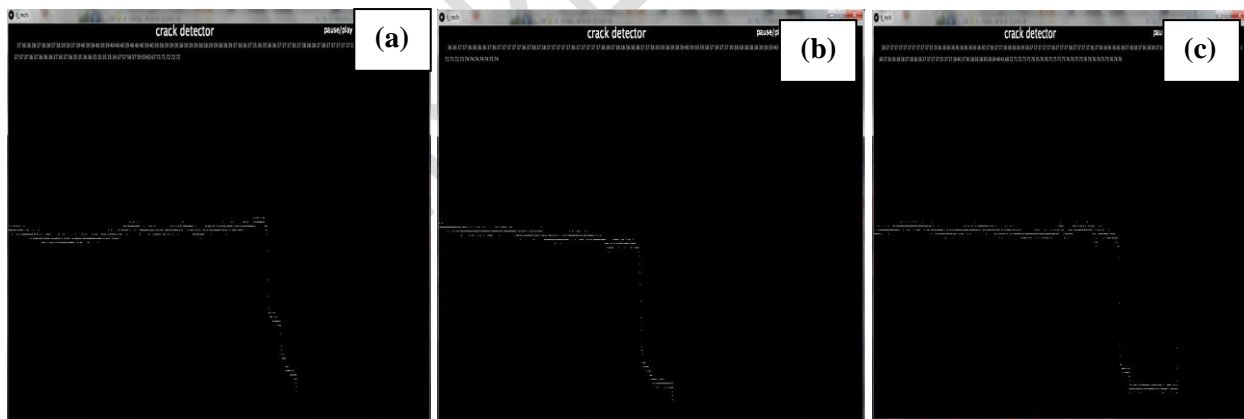
331 During the post-test carried out on the galvanized steel pipe at the first section lift off was completely
 332 eliminated which gave a more regular pulse signal compared to the longitudinal defects test. Pulse signal
 333 showed significant low amplitude at the points where the coil encountered defects which was a strong
 334 indication. The test on the second section showed also complete elimination of lift off with the pulse
 335 signal regular till defects were encountered by the coil. This was indicated distinctively by the low
 336 amplitude that was seen on the display. The third test carried out in the third section of the pipe also
 337 showed no visible lift off on the display. The pulse signal showed the expected low amplitude at the
 338 points of defects. The visual display of the results can be seen from Fig. 7 below, also showing the
 339 numerical values at the top of each of the display which is the inverse of the impedance on the coil as the

340 test was been carried on and it is in line with the pulse signal displayed.

341
342 **Figure 7:** Result from the tested done galvanized pipe with axial defects in (a) section 1 (b) section 2 (c) section 3
