Aims: Bathymetry survey of Part of Badagry Creek and Yewa River was conducted with the aim of investigating the topography changes in depth between two epoch dataset by calculating the volume of sediment and dredged material between the two periods.

Study Design: Depth sounding at 100m interval, data grid of 100m interval, constant vessel speed of 2.2m/secs (8Km/hr) for data capture, data storage at interval of 30 Secs was ensured at both the Creek and the river.

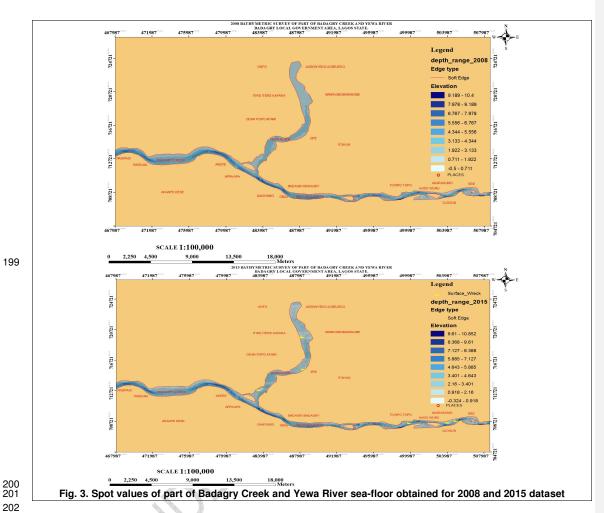
The results presented in this section are in form of tables, maps and charts of relevance which represent processed dataset 2008 and 2015. Fig. 3 is a processed bathymetric dataset for 2008 and 2015 survey as observed with the echo sounder plotted with ArcGIS 10.2.1 software. In 2008, the depth observed ranges from (-0.5 to 10.4)m with area of low depth ranges from (-0.5 to 0.711)m and area of high depth of (9.189 to 10.4)m while in 2015, the depth observed ranges from (-0.324 to 10.852)m with area of low depth of (-0.324 to 0.918)m and area of high depth of (9.61 to 10.852)m (see profile graph in fig. 4). Fig. 4 showed the profile graph of depth variation along the seabed. Fig. 5 showed depth variation between 2008 and 2015 and their depth residuals overtime. Fig. 6 described the spatial changes that occurred between 2008 and 2015. To detect depth change over time on the creek and river topography. A graphical plot of change in sea bed topography has also been shown in Fig. 7. Fig. 8a is the volume of sediment deposited with its query while fig. 8b is the volume dredged volume with their query. Tables 2 show the processed bathymetric data for dataset 2008 and 2015. Table 3 shows depth residual data from 2008 and 2015 survey.

From fig. 3, the deepest points within the Badagry creek and Yewa River occur in the southern area (base) of the water body contrary to expectations of a deeper inner seaward region. This pattern is suspected to have taking place as a result of dredging activities going on around the southern shoreline of the Badagry creek and the river. This is further proved by the seabed variation pattern drawn in fig. 4, 5 and 7. The inadequate nature of the profile graph shows an uneven sea bed topography which likely could have resulted from erosion and aggravated by dredging activities (see fig. 4, 5 and 7). From fig. 6, it showed that spatial changes exist in both the Creek and the River. The results also showed that area fill is greater than the area fill in Yewa River while in Badagry Creek, it showed almost equal area fill and area cut.

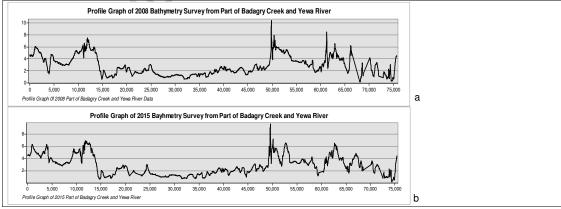
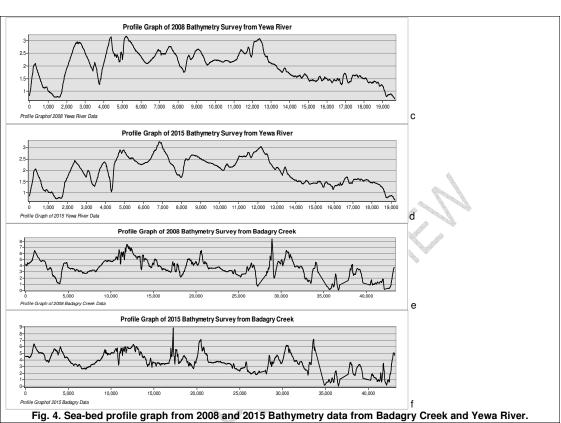
Fig. 4 above showed that from the profile graph (a & b), at 20,000m (20km) in 2008, the depth was 2.0m while in 2015, the depth was 2.5m which implies that dredging has taking place after 2008 observation leading to increase in depth in 2015. At 40,000m (40km) in 2008, the depth was 2.15m while in 2015, the depth was 1.90m which denotes sediment deposit in 2008. From profile graph (c & d), it showed that at 2500m (2.5km) in 2008, the depth was 2.4m while in 2015, the depth was 2.2.8m which means that dredging has taking place after 2008 observation. At 15500m (15.5km), the depth was 1.40m while in 2015, the depth was 1.26m which denotes sediment deposit in the area (area fill). Profile graph (e & f) showed that at 4000m (4km) in 2008, the depth was 1.01m while in 2015, the depth was 4.90m which indicates that dredging has taking place after 2008 observation. At 15000m (15km) in 2008, the depth was 3.80m while in 2015 the depth was 2.90m which indicates sediment deposit has taking place after 2008 observation.
