A Study of Wafer Backgrinding Tape Selection for SOI Wafers

[1]*STMicroelectronics, Inc., Calamba City, Laguna, Philippines 4027*

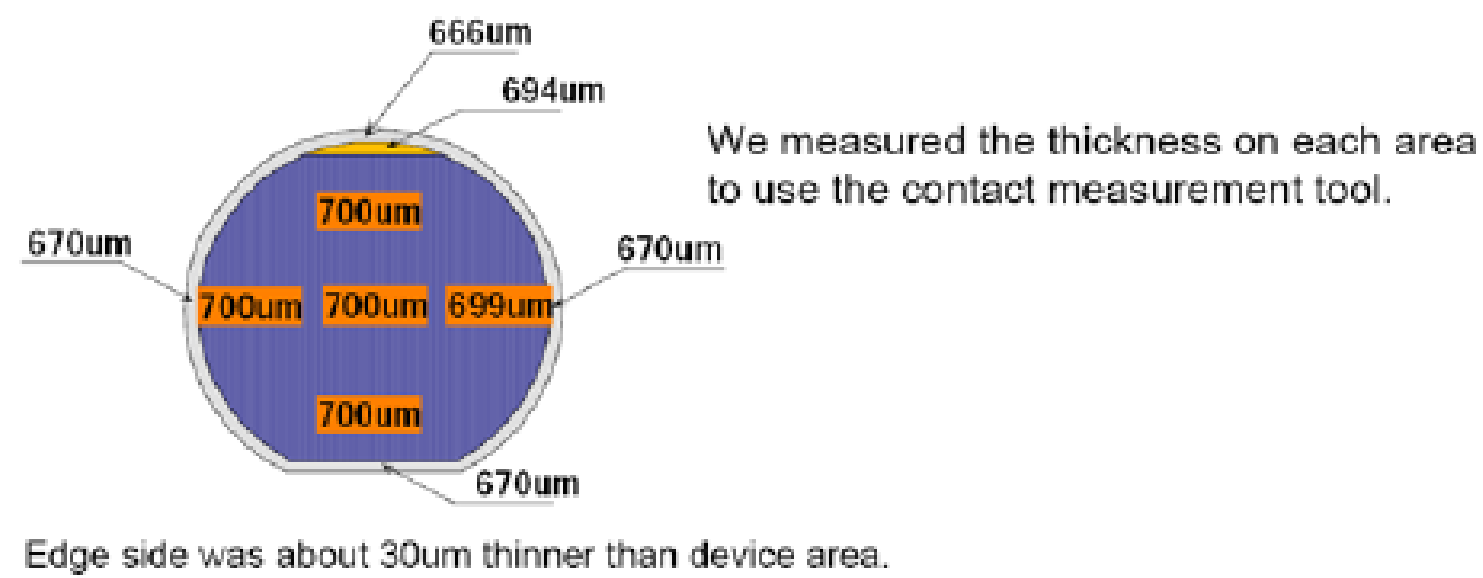
Fig. 2. Wafer thickness prior taping

In line with the stepping effect, SOI wafers are measured prior wafer taping and observed to have the edge area 30µm thinner than the device area as depicted in Fig. 2. Also, the wafers after having taped are observed to have a warpage in Fig. 3 of 0.5mm around the edge area.

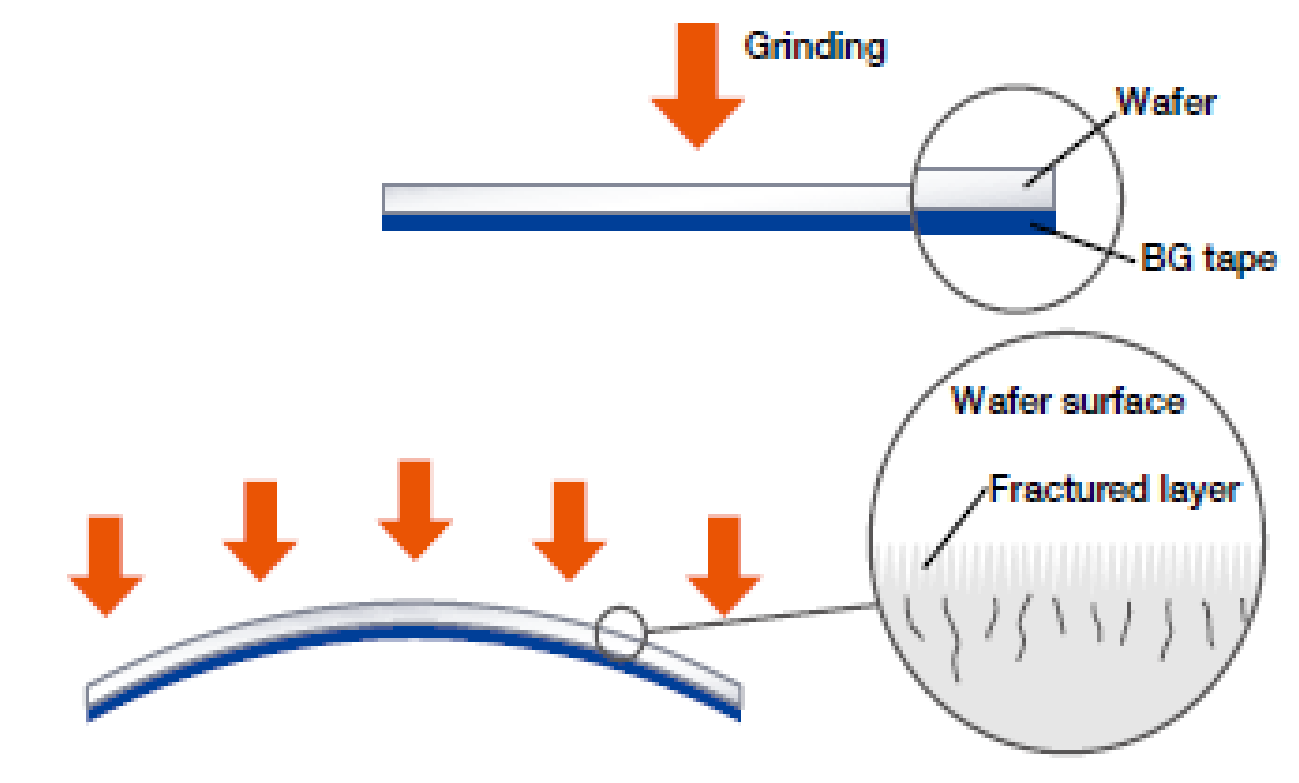
87
88
89 **Fig. 4. Normal warpage**
90

79
80 A common wafer mechanism is a normal warpage [5] depicted in Fig. 4. This is generally
81 caused by the natural stress created by mechanical backgrinding. The proportional
82 relationship of wafer warpage and mechanical stress states that when the final thickness
83 decrease this probably caused by high mechanical stress that may lead to high wafer
84 warpage. Although subsequent assembly processes contribute to warpage, these processes
85 also adapt with the development and trend on wafer technology [6-7].
86

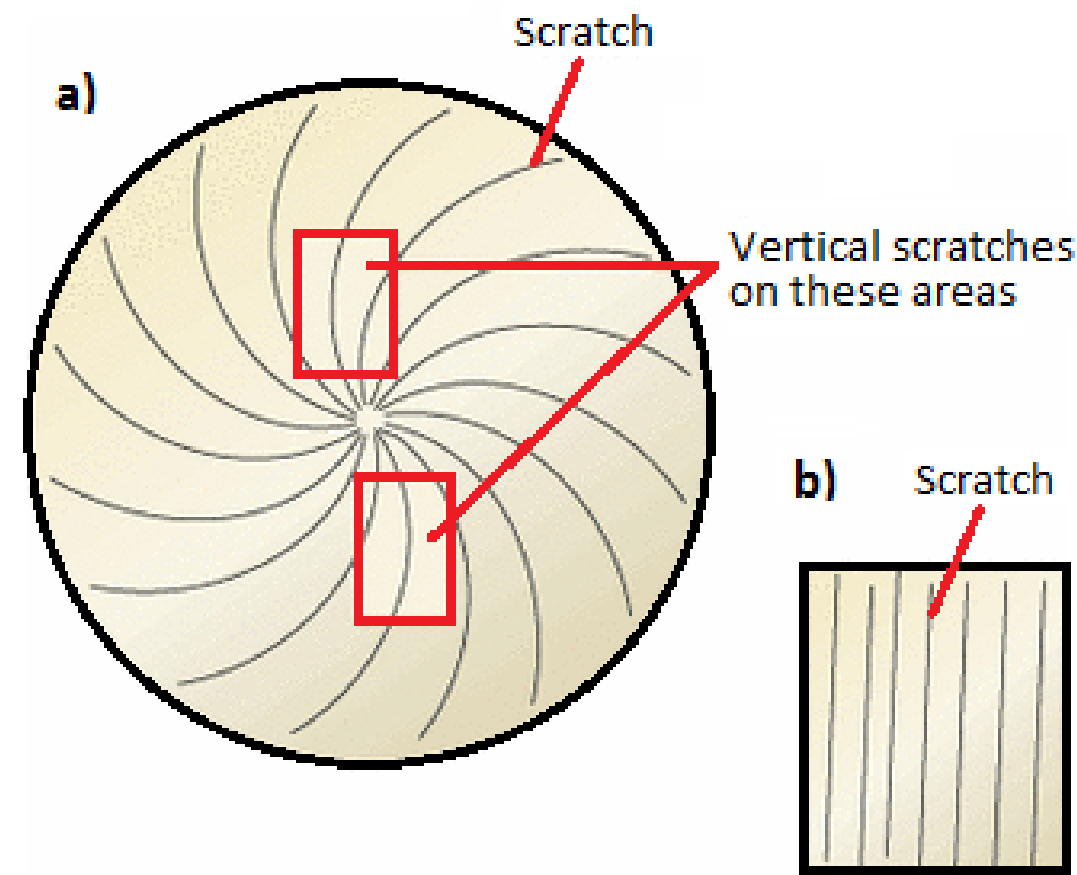
Fig. 5. Vertical scratches after wafer backgrinding

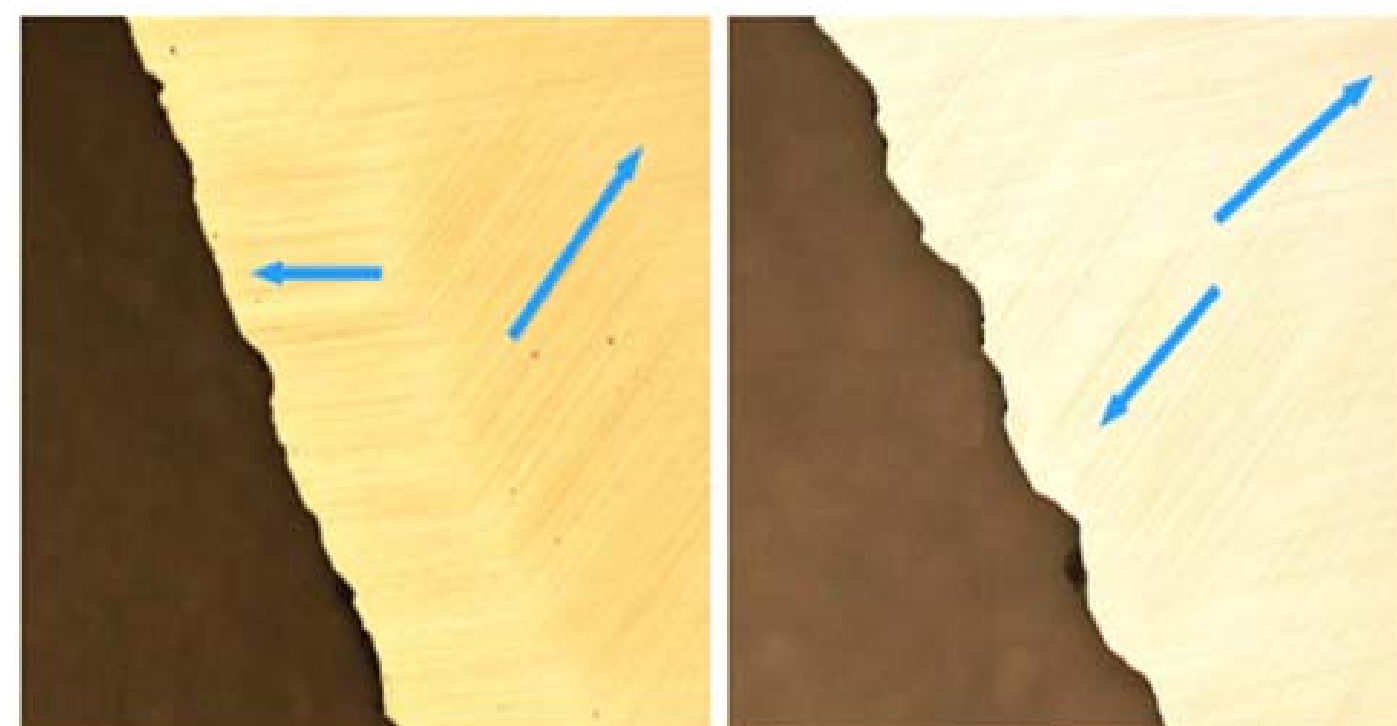
Fig. 7. Back side image of the SOI wafer

Back side image of the wafer has also been inspected using high magnification microscope as shown in Fig. 7. Uneven surface was observed at the edge of the wafer, which can also be considered a potential cause of broken wafer during process of transporting wafer from one station to another at pre-assembly. Also, the occurrence of uneven surface at the back of the wafer also coincide with the step at the edge of the wafers.

For future works, detailed mathematical model and measurement indexes should be considered and qualified. For further improvement, it is highly recommended to use high vacuum efficient chuck table to properly handle incoming wafer warpage and ensure good flattening on the chuck table and eliminating the possibility of inferior grinding. Redesign of special robot arms should also be considered to eliminate the possibility of wafer breakage when handling or unloading thinner wafers after grinding or use an inline BG-mount system. Moreover, a special process should be considered wherein making an outer circumference lip, where no grinding pressure is applied on the edge of the wafer during backgrinding. For ensuing critical processes like that of the wafer saw, discussions in [9] are helpful to prevent or eliminate defects related to wafer preparation. Also, it is highly important that the assembly manufacturing processes ensure appropriate ESD checks and controls. Discussions quoted in [10] are very helpful to comprehend ESD-related controls.
