MODELING OF SUBSURFACE INTEGRITY USING DAR-ZARROUK PARAMETERS. A CASE STUDY OF IKEKOGBE UBE PRIMARY SCHOOL, EKPOMA, EDO STATE, NIGERIA.

Abstract

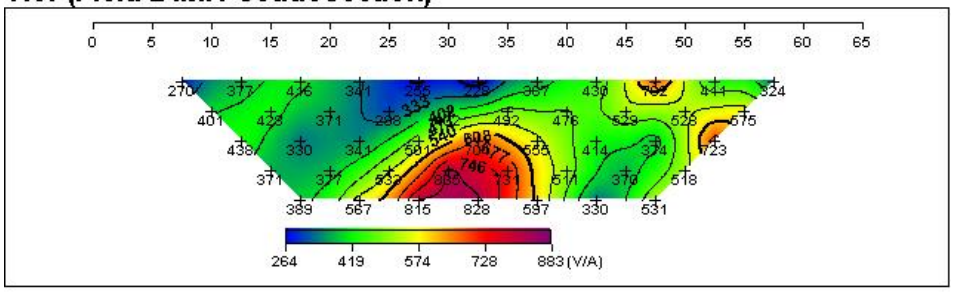
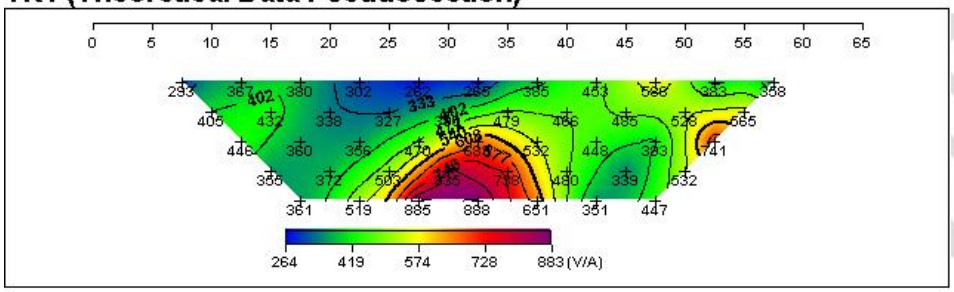
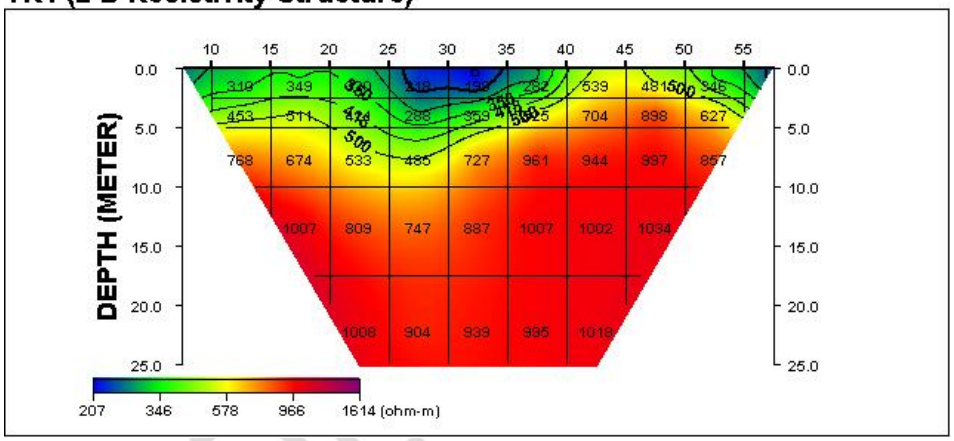
Figure 4a. Dipole – Dipole Pseudo-section along Traverse One

The 2-D Pseudosection was produced from the dipole-dipole data taken along the three (3) traverses Figure 4 (a-c). The Dipole-Dipole traverses covered a distance of about 60 meter along East to West Orientation. It delineated three to four major subsurface material/layer components, identified with various colour for easy characterisation; The layer lithological materials varies from Topsoil comprises of clay, clayey sand and sandy clay material as indicated in green/blue colour with layer resistivity variation of 119 to 207 Ωm. Following this layer is another characterised by moderately low resistivity variation from 207 to 459 Ωm with the dominant resistivity being between 15.6 Ωm and 112.6 Ωm. These was characterised by lithologic units that can be classified as sandy shales, and shaly sands, with layer thickness varying from 1 to 25 m they are indicated with green, light green, and green/blue colour. These zones are characteristically weak and made up of attributes of low foundation integrity. The few zones with materials of high/moderate integrity can be found around 10 to 15 m and 40 to 45 m to a depth of 5 m along traverse one and two, also within 10 to 25 m along traverse three.

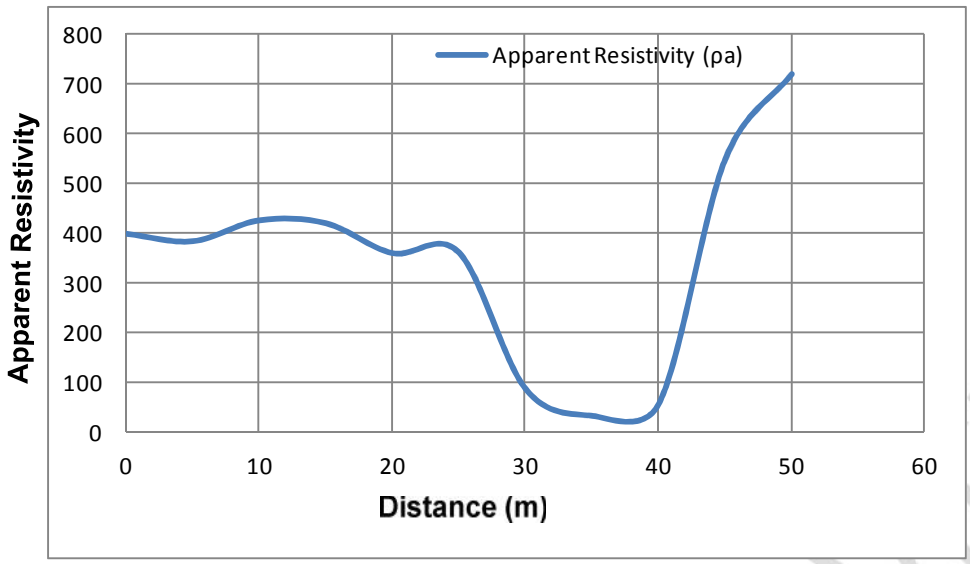
Figure 5a. Horizontal Profiling along Traverse One

Horizontal profiling was produced from the Wenner data obtained along the traverse one and three (Figure 5a and 5b). The result obtained further revealed that the zone is generally weak with apparent resistivity varying from 10 to 200 Ωm between 30 to 40 m along traverse one while within 5 to 25 m demonstrated fear competence with apparent resistivity value ranging from 380 to 400 Ωm (Figure 7a). Weak zone was also observed within the 30 to 55 m along traverse three with apparent resisitivity varying from 200 to 280 Ωm (Figure 7b).

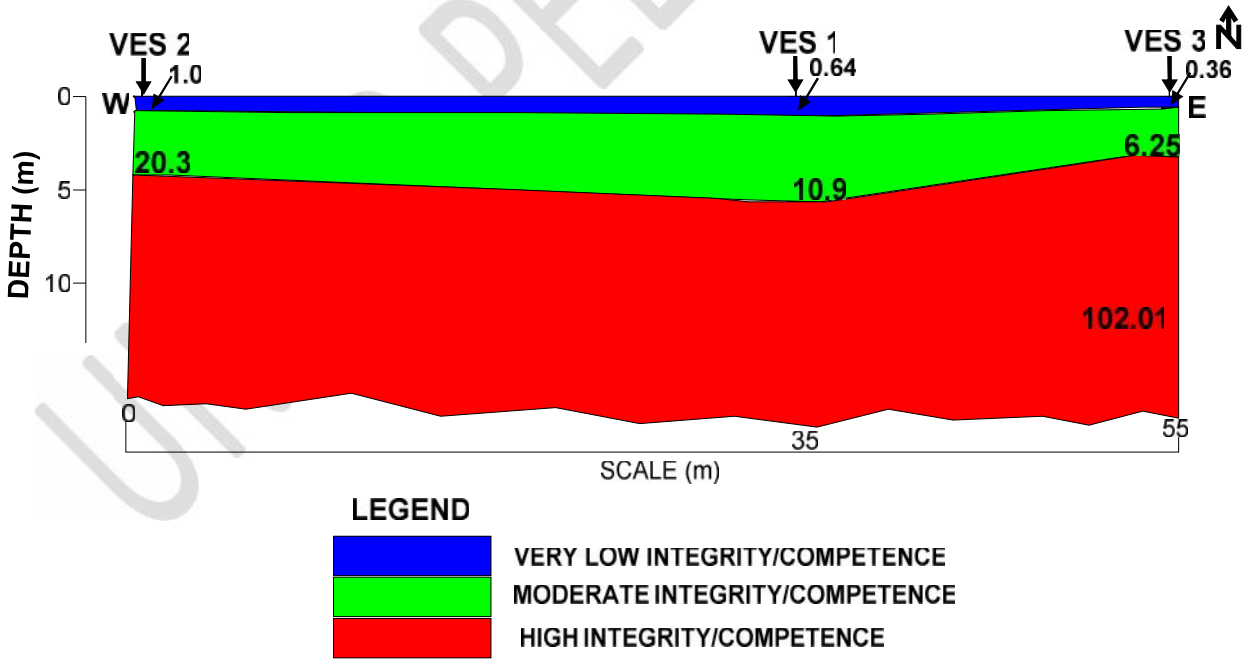
Figure 7a. Subsurface Integrity Model of the Study Area along traverse one

The integrity models were represented by the 2-D view of the second order parameters (total longitudinal conductance and total transverse resistance) derived from the inversion of the electrical resistivity sounding data. The integrity model along Traverse 1 to traverse 3 (Figure 7a to 7c) attempted to correlate the subsurface integrity/competence across the study area. Three (3) to four (4) subsurface integrity models were identified within the investigated area and integrity/competence were summarized in Table 2. The very low integrity/competence values

ranges from 0.36 to 1.0 m to a depth of 1.2 m, the low integrity/competence has a value of 2.56 m with depth of 2.2 m. the moderate integrity/competence values ranges from 6.25 to 16 m to a depth of 6.3 m while high/very high integrity/competence values ranges from 25 to 353.4 m. The values from very low to low integrity/competence are an indicative that this layer may not be of any major interest since it is expected to be excavated and more so that it is not competent enough. However, the foundation of part of the building/structures was located within the upper 1.5 m which was of very low to low integrity/competence.

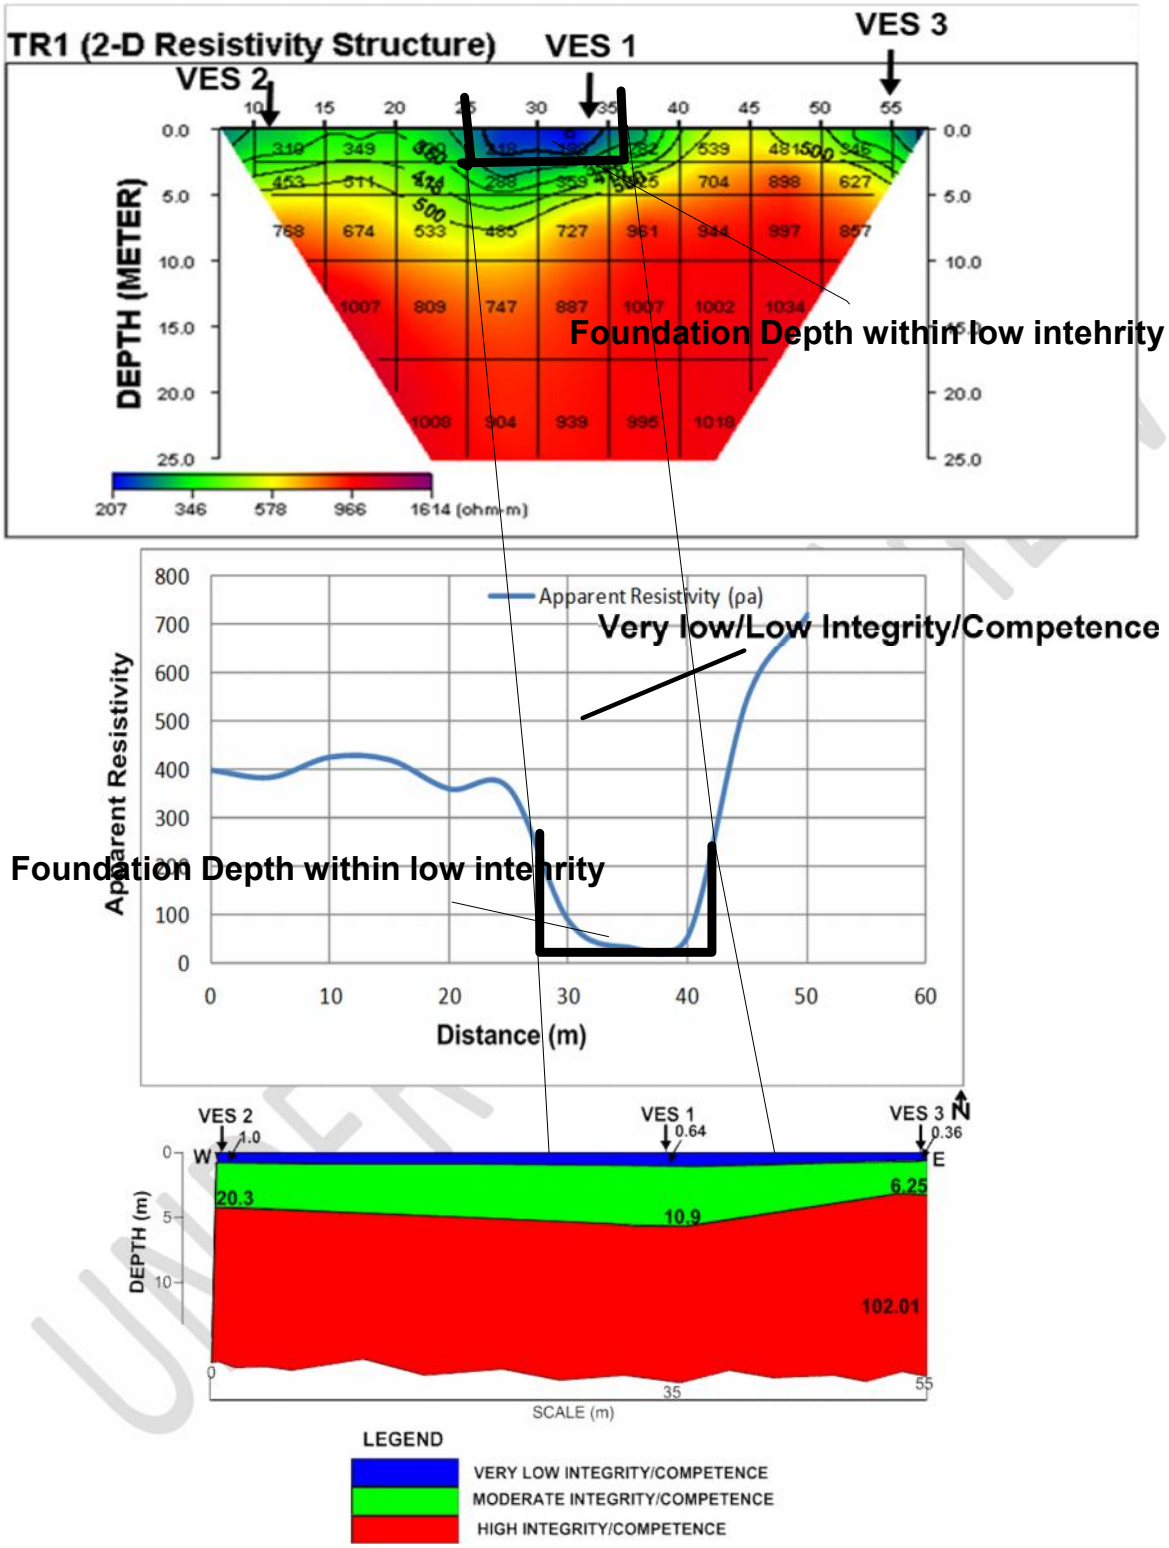
Figure 8a. Correlation of Dipole-Dipole Pseudo-section, Horizontal Profiling with Subsurface Integrity Model along Traverse one

Figure 8 displays the correlation of result obtained from the geophysical techniques. The Wenner profiling observed at a distance 28 to 42 m demonstrated low integrity/competence with apparent

resistivity value ranging from 10 to 200 Ωm which coincides with the low resistivity zone observed on the dipole-dipole pseudo-section at a distance at a distance 25 to 33 m. This also agree with subsurface integrity model at the same distance which indicate very low/low integrity/competence that lead to crack on the building (Figure 8a). Also the low resistivity zone (weak zone) 0bserved on the dipole-dipole pesudosection at distance between 10 to 25 m at depth of 0 to 25 m coincide with the very low subsurface integrity model on Figure 8b. The Wenner profiling zone is generally weak with apparent resistivity varying from 180 to 300 Ωm at a distance of 38 to 60 m correlate with the low resistivity zone observed on the dipole-dipole pseudo-section at distance between 38 to 55 m and with the subsurface integrity model which indicate very low/low integrity/competence (Figure 8c). Correlating the results with subsurface integrity model along traverses one and three highly show a very low/low integrity/competence with the foundation of the classroom designated on this layers. The information obtained from this attempt correlated effectively with the result obtained from the lateral resistivity profiling as well as the dipole – dipole techniques. The 2D imaging reveals that there is a weak zone that existed between 25 to 35 m. The information further revealed that it occurred from the near surface to depth of about 2 meters before the competent layer. A similar situation also occurred at about 55 m towards the end of the profile. However, the control traverse (TR2) gave useful information on the possibility of a major weak zone occurring between 15 to 35 m along the control profile which gradually thins out towards the end of the control traverse. It is suspected that the major weak zone that occurred at the control traverse (TR2) could have given rise to near surface water flow channel/seepage which could have affected profile 1 geodynamics in such a way as to create a weak zone to allows for underground near surface water flow channel/seepage, while considering the fact that Ekpoma sedimentary environment is noted to be prone to flood zone challenges occasioned by strong surface and near surface high current water flow. Hence, the problem may not be unconnected with near surface groundwater flow emanating from the weak zone region from the control traverse 2. In view of this situation, there is a need for proper and well planned drainage control and management in the study area. The research revealed that the problem of structural failures/crack noticed along the building walls and axis was not as a result of human problem alone, but mainly the existence of very low/low integrity/competence upper layers which contributed a great deal to the cracks observed on the classroom block. These results reveal that the Electrical resistivity techniques used for this study are complimentary.

The present study was carried out in order to be able to unravel the causes of major cracks along the side of a major class room block at Ikekogbe UBE Primary School, Ekpoma, Edo State, Nigeria in less than five (5) years after it was constructed. The investigation involved Electrical Resistivity method using three techniques; Vertical Electrical Sounding (VES), 2-D Electrical Resistivity Tomography (ERT) and Horizontal Profiling (HP) and three traverses were established along E-W directions The results from the VES interpretation was used to determined second order parameters such as the total transverse resistance (T) and the total longitudinal conductance (s). The second order parameters were used to generate subsurface integrity model which comprises of very low, low, moderate, high and very integrity/competence. Correlating the results with subsurface integrity model along traverses one and three, there was a high degree of correlation as this region coincides with the very low/low integrity/competence with the foundation of the classroom overlying this layers. This model can be applied in any part of the sedimentary environment. The research displays that this problem was an avoidable problem if the building engineers and the contractors should have availed themselves of services of geophysicist who would have advised on the way to go about the construction. Furthermore, it is recommended that thick drainage be constructed as a remedy along the flow direction of the erosion part.
