Original Research Article

Occupational noise and vibration assessments in forest harvesting equipment in north-eastern Brazil

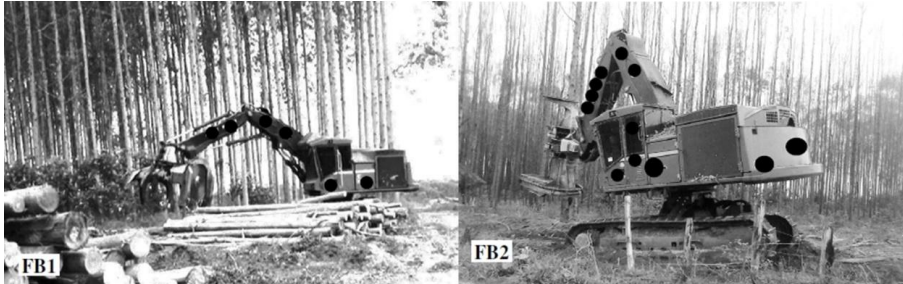
The following are the crawler Feller-buncher equipment without leveling device - FB1; crawler Feller-buncher with leveling device - FB2 (Fig. 1). This equipment is used to cut down and accumulate trees in rows.

FIG. 1 Crawler Feller-buncher without leveling device – FB1; Crawler Feller-buncher with leveling device – FB2

For the work on Feller-bunchers (FB1 and FB2), the level of attention should be increased, as they presented very high noise levels and very close to exceeding the maximum allowable exposure limit of 85 dB (A). If exposure above the limit may occur, a new adjustment should be proposed. In this case, for every 5 dB(A) above the limit, the operator will have a 50% reduction in their working hours [18]. However, there are no productivity targets to be adjusted in any of the evaluated equipment due to noise.

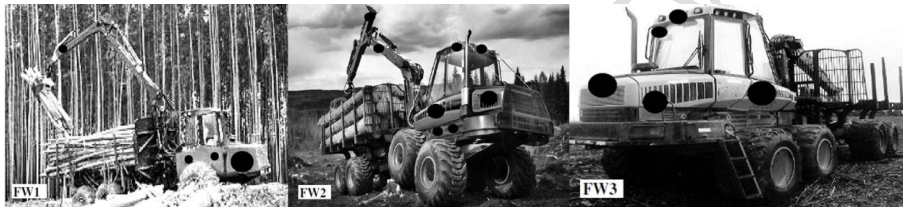
Forwarder-type equipment has a load capacity of 1400 kg, cab suspension system and 6 ~~xx~~ 6 - FW1 and 8 ~~xx~~ 8 - FW2 and FW3 traction tire wheels (Fig. 2). This equipment is used for logging and its main function is to take the wood to the edge of the area.

FIG. 2 Tire Forwarder with 6x6 cab suspension system – FW1; Tire Forwarder with 8x8 cab suspension system – FW2 and FW3

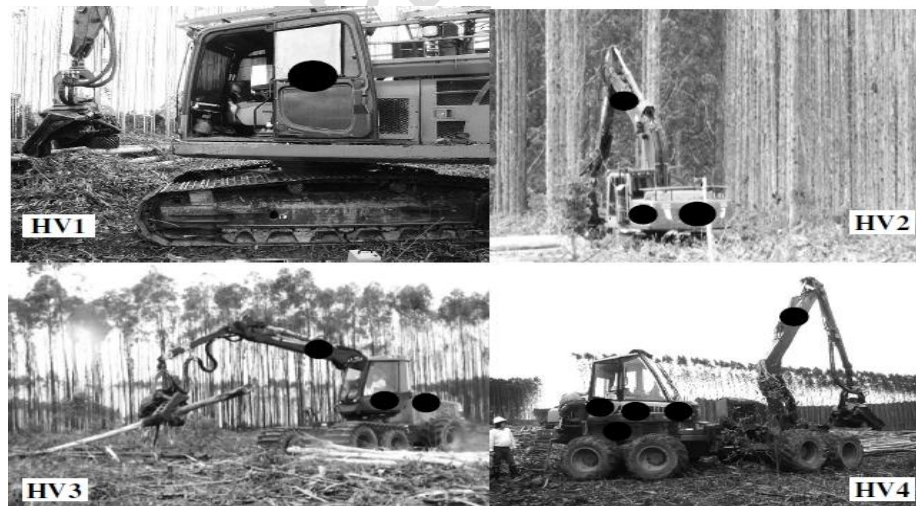
And finally Harvester-type equipment, with crawler and appropriate head - HV1 and HV2; Harvester with tires and appropriate head - HV3 and adapted tire agricultural machinery with

Harvester head - HV4 (Fig. 3). This equipment simultaneously performs felling, delimiting, tracing, and wood stacking operations.

FIG. 3 Crawler Harvester– HV1 and HV2; Tire Harvester – HV3; Adapted tire agricultural machinery with Harvester head – HV4
